State of Washington
DEPARTMENT OF HEALTH

December 13, 2021

Subject: Maury Mutual Water Co (ID#52100)
King County
2021 Routine Sanitary Survey

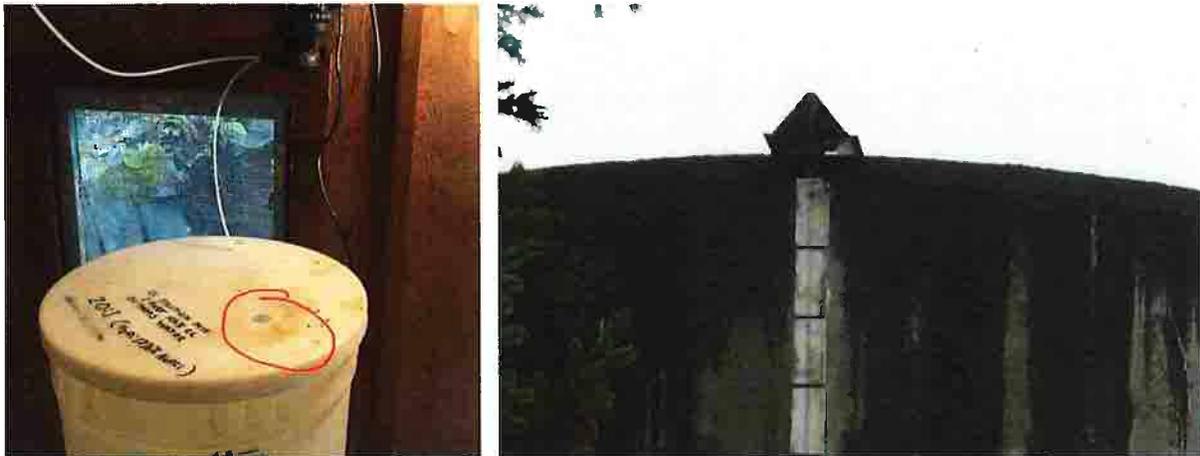
1. Think like a bug. Cover the direct openings to the sodium hypochlorite tanks in the spring house and well house. Consider venting to the exterior of the building (with an air gapped downward facing screened vent) to protect the equipment and plumbing from premature corrosion.

2. Think like a bug and consider surface runoff. Inspect and photograph the level indicator penetration of the storage tanks. If there is an opening around the cable, consider retrofitting hard piping around the level indicator cable.

Figure 1. (Left) Please cover the opening on the lid of the sodium hypochlorite solution tanks. (Right) Lower storage tank level indicator design is notorious for not providing a good seal or barrier to prevent roof surface water flow from entering the tank. Please investigate and respond accordingly.
